# **CERTIFICATE OF TESTING**

PRODUCT: INGRESS PROTECTION (IP 68) TEST OF WATER METER CUSTOMER: M/s V A VALVES – UDYOG NAGAR- JALANDHAR- 144 004

Report No.: FCRI/EQL/ENV/15-16/013

Ingress protection (IP 68) test was conducted on Water Meter for M/s V A VALVES
- UDYOG NAGAR, JALANDHAR-144 004, as per IEC 60529 Edition 2.2 2013-08 at the test facility of Fluid Control Research Institute, Palakkad.

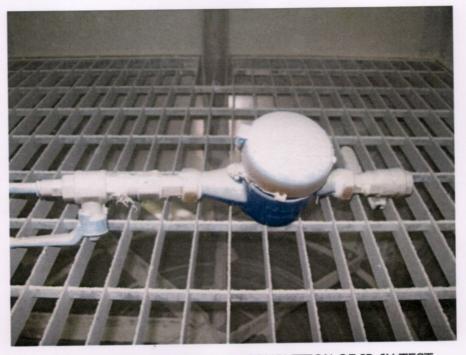
PLATE A: WATER METER AFTER COMPLETION OF IP 6X TEST

- Ingress Protection Test (IP 6X): There was no deposit of dust particle observed inside the registration box.
- Ingress Protection Test (IP X8): There was no ingress of water droplet observed inside the registration box.

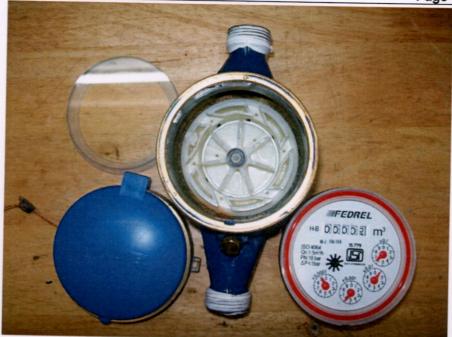
PLATE B: WATER METER AFTER COMPLETION OF IP 6X TEST

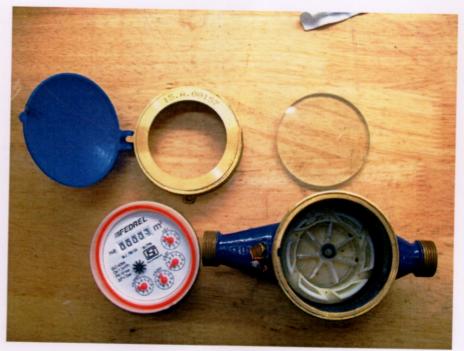
PLATE C: WATER METER AFTER COMPLETION OF IP X8 TESTS
